HISTORIC AMERICAN BUILDINGS SURVEY
INVENTORY

2. NAME *Orrin Thompson Mansion*

DATE OR PERIOD *1832*
STYLE *Greek Revival*
ARCHITECT
BUILDER *Orrin Thompson*

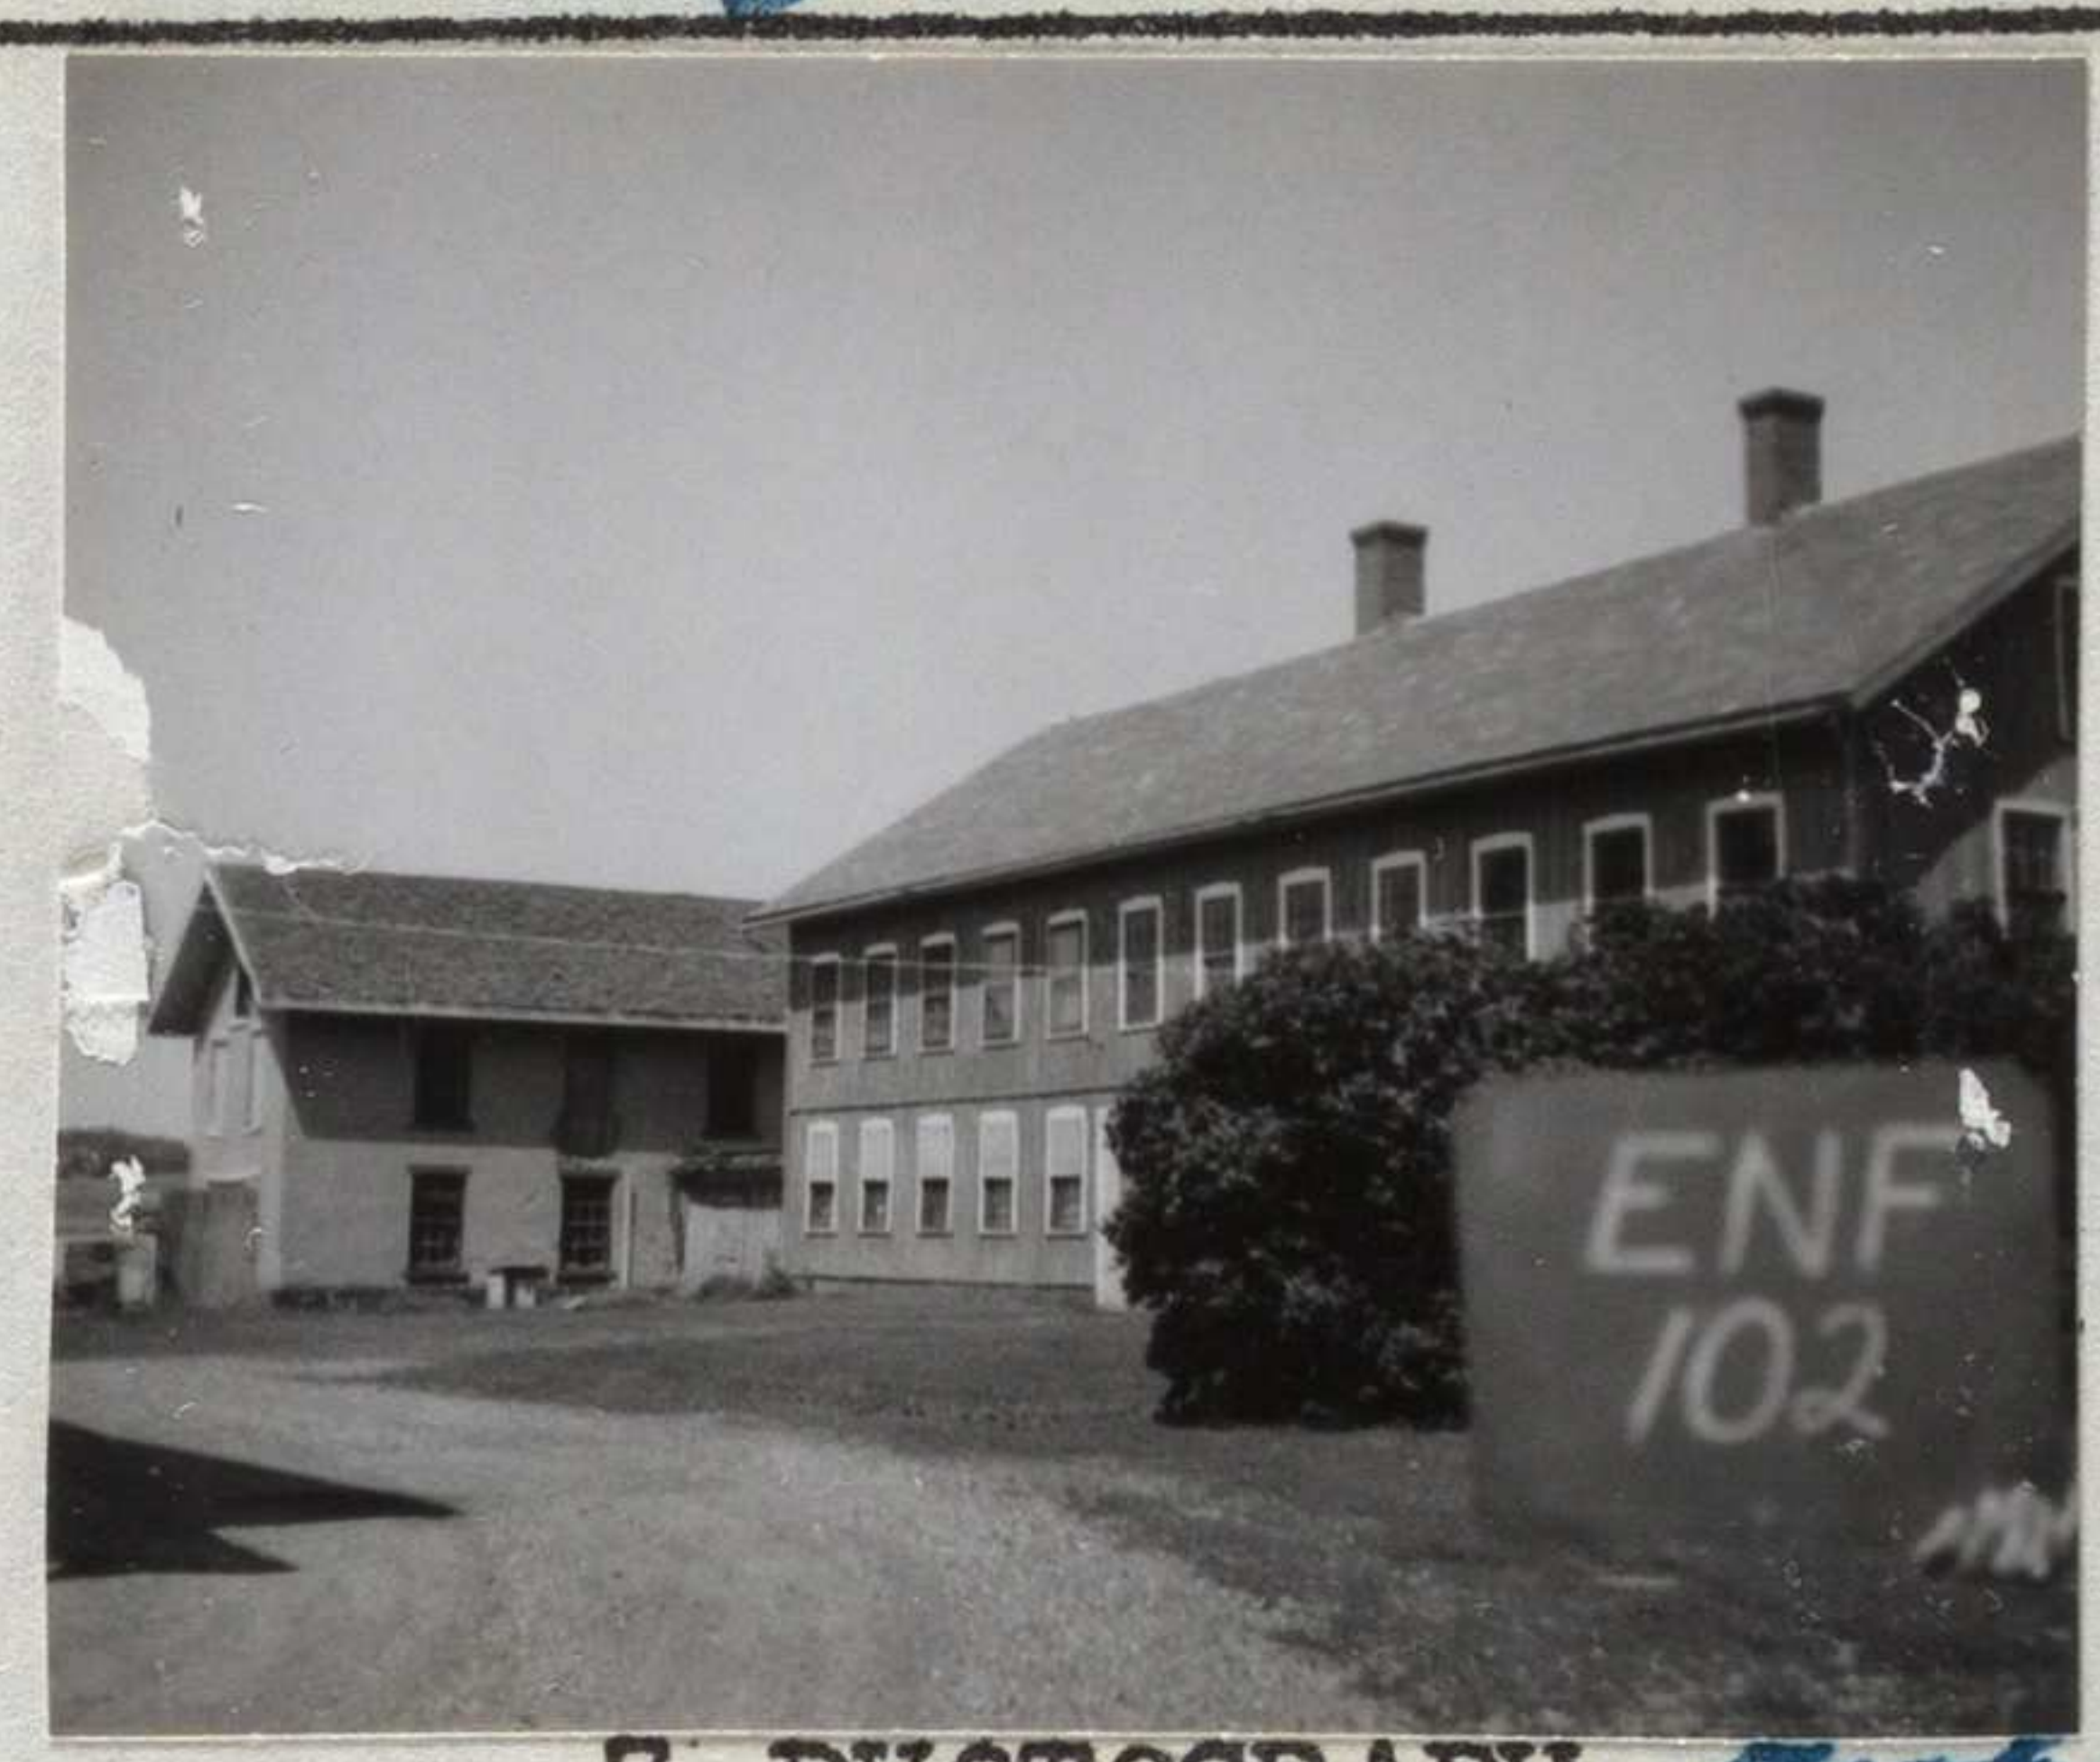
6. LOCATION MAP (Plan Optional)	7. PHOTOGRAPH <i>Enf 102</i>
8. PUBLISHED SOURCES (Author, Title, Pages) INTERVIEWS, RECORDS, PHOTOS, ETC.	9. NAME, ADDRESS AND TITLE OF RECORDER <i>Eric J. Endersby</i> <i>Dale Gudmundson</i> DATE OF RECORD <i>7/17/67</i>

4. NOTABLE FEATURES, HISTORICAL SIGNIFICANCE AND DESCRIPTION <i>This hand-pegged, board and batten, barn-like building has 12 bays. The Main door has both transom and sidelights. The windows are 6/6 and have

wood lintels, as do the doors. The roof is slate and there are two chimneys. One of the Cybulski brothers showed us through the building which is now nearly entirely unused except for the use of potato storage. The first floor is entirely used for floored in brick and was used as an ice house + slaughter house. The staircase has the simple newel posts and banisters common to all shaker buildings. Upstairs one large room still has the tobacco sorting tables used during Shaker times. Other residential rooms have the built in drawers of shaker practicality built in. A little furniture also remains over.</i>	OPEN TO PUBLIC <i>No</i>

Attached to this building is a stucco-covered brick
barn with wood shingled roof, brick floor and
brass tone ~~found~~ lintels.

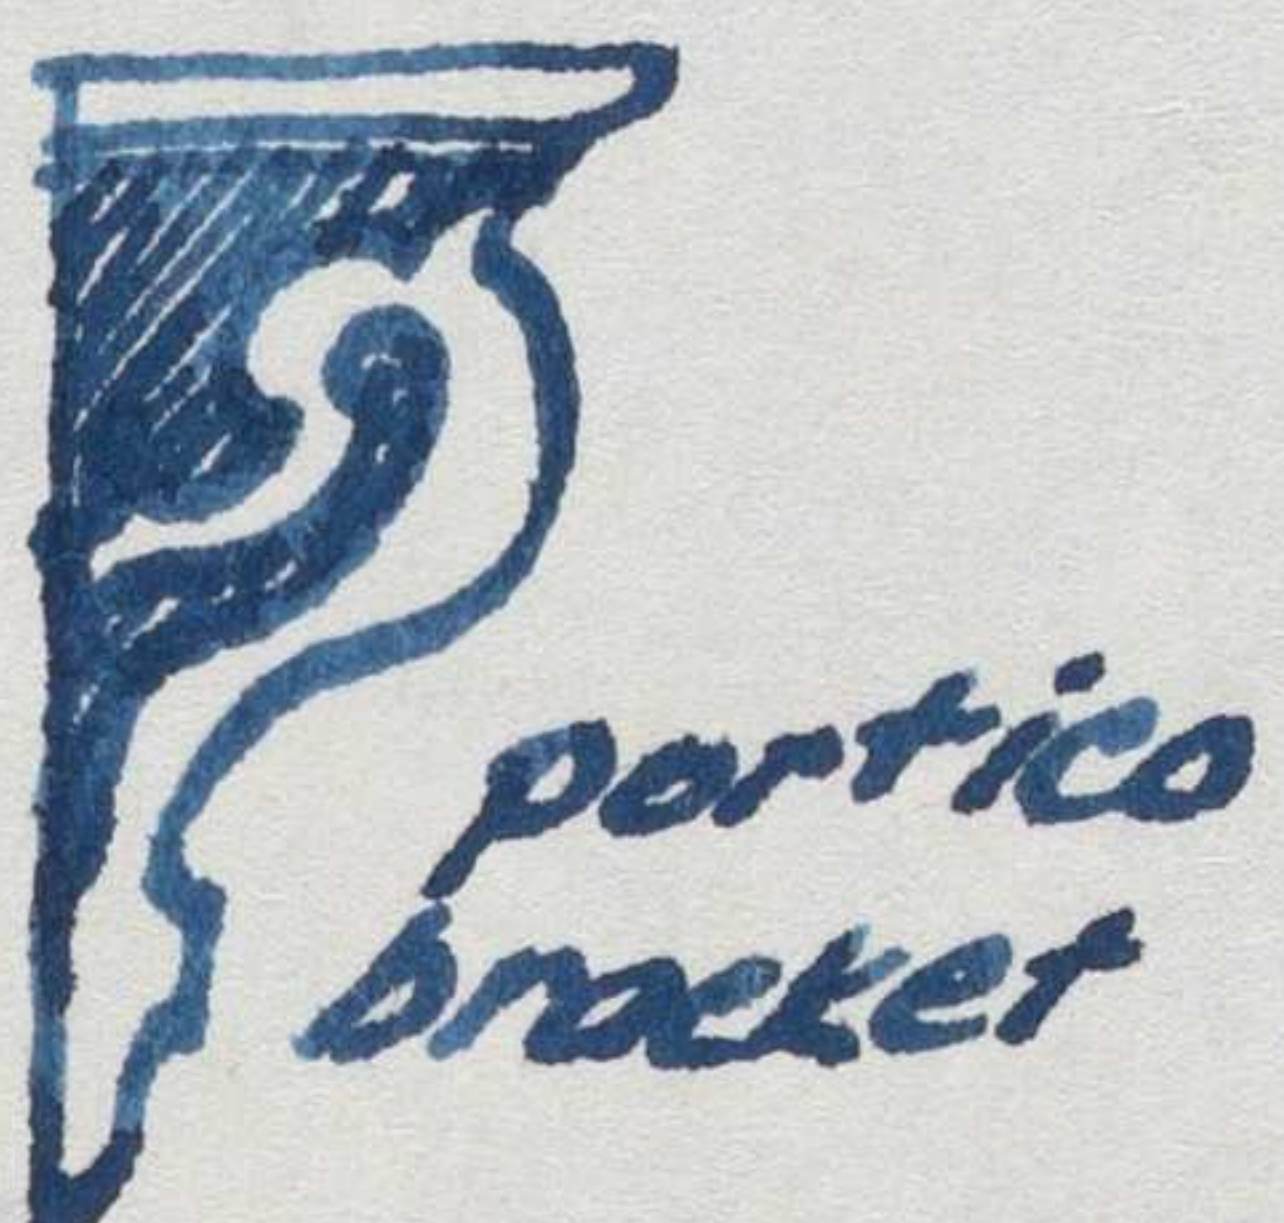
<p>portico bracket</p>

<p>1. STATE <i>CT</i> COUNTY <i>Hartford</i> TOWN <i>Enfield</i> VICINITY STREET NO. <i>School St. (Hazardville)</i></p> <p>ORIGINAL OWNER? ORIGINAL USE <i>Residence</i> PRESENT OWNER? PRESENT USE <i>Residence</i> WALL CONSTRUCTION <i>clapboard</i> NO. OF STORIES <i>2</i></p>		<p>HISTORIC AMERICAN BUILDINGS SURVEY INVENTORY</p> <p>2. NAME</p> <p>DATE OR PERIOD <i>1840?</i> STYLE <i>Italian Villa Style</i> ARCHITECT BUILDER</p> <p>3. FOR LIBRARY OF CONGRESS USE</p>		
<p>4. NOTABLE FEATURES, HISTORICAL SIGNIFICANCE AND DESCRIPTION</p> <p><i>This cross-shaped house has a brick foundation, under the three bays of the main facade. The regular windows are 2/2, the bay window to the South segmental headed 1/1 windows. The entablature has fine brackets as does the front portico. The monitor roof rises to double segmental topped windows framed in double brackets.</i></p> <div>

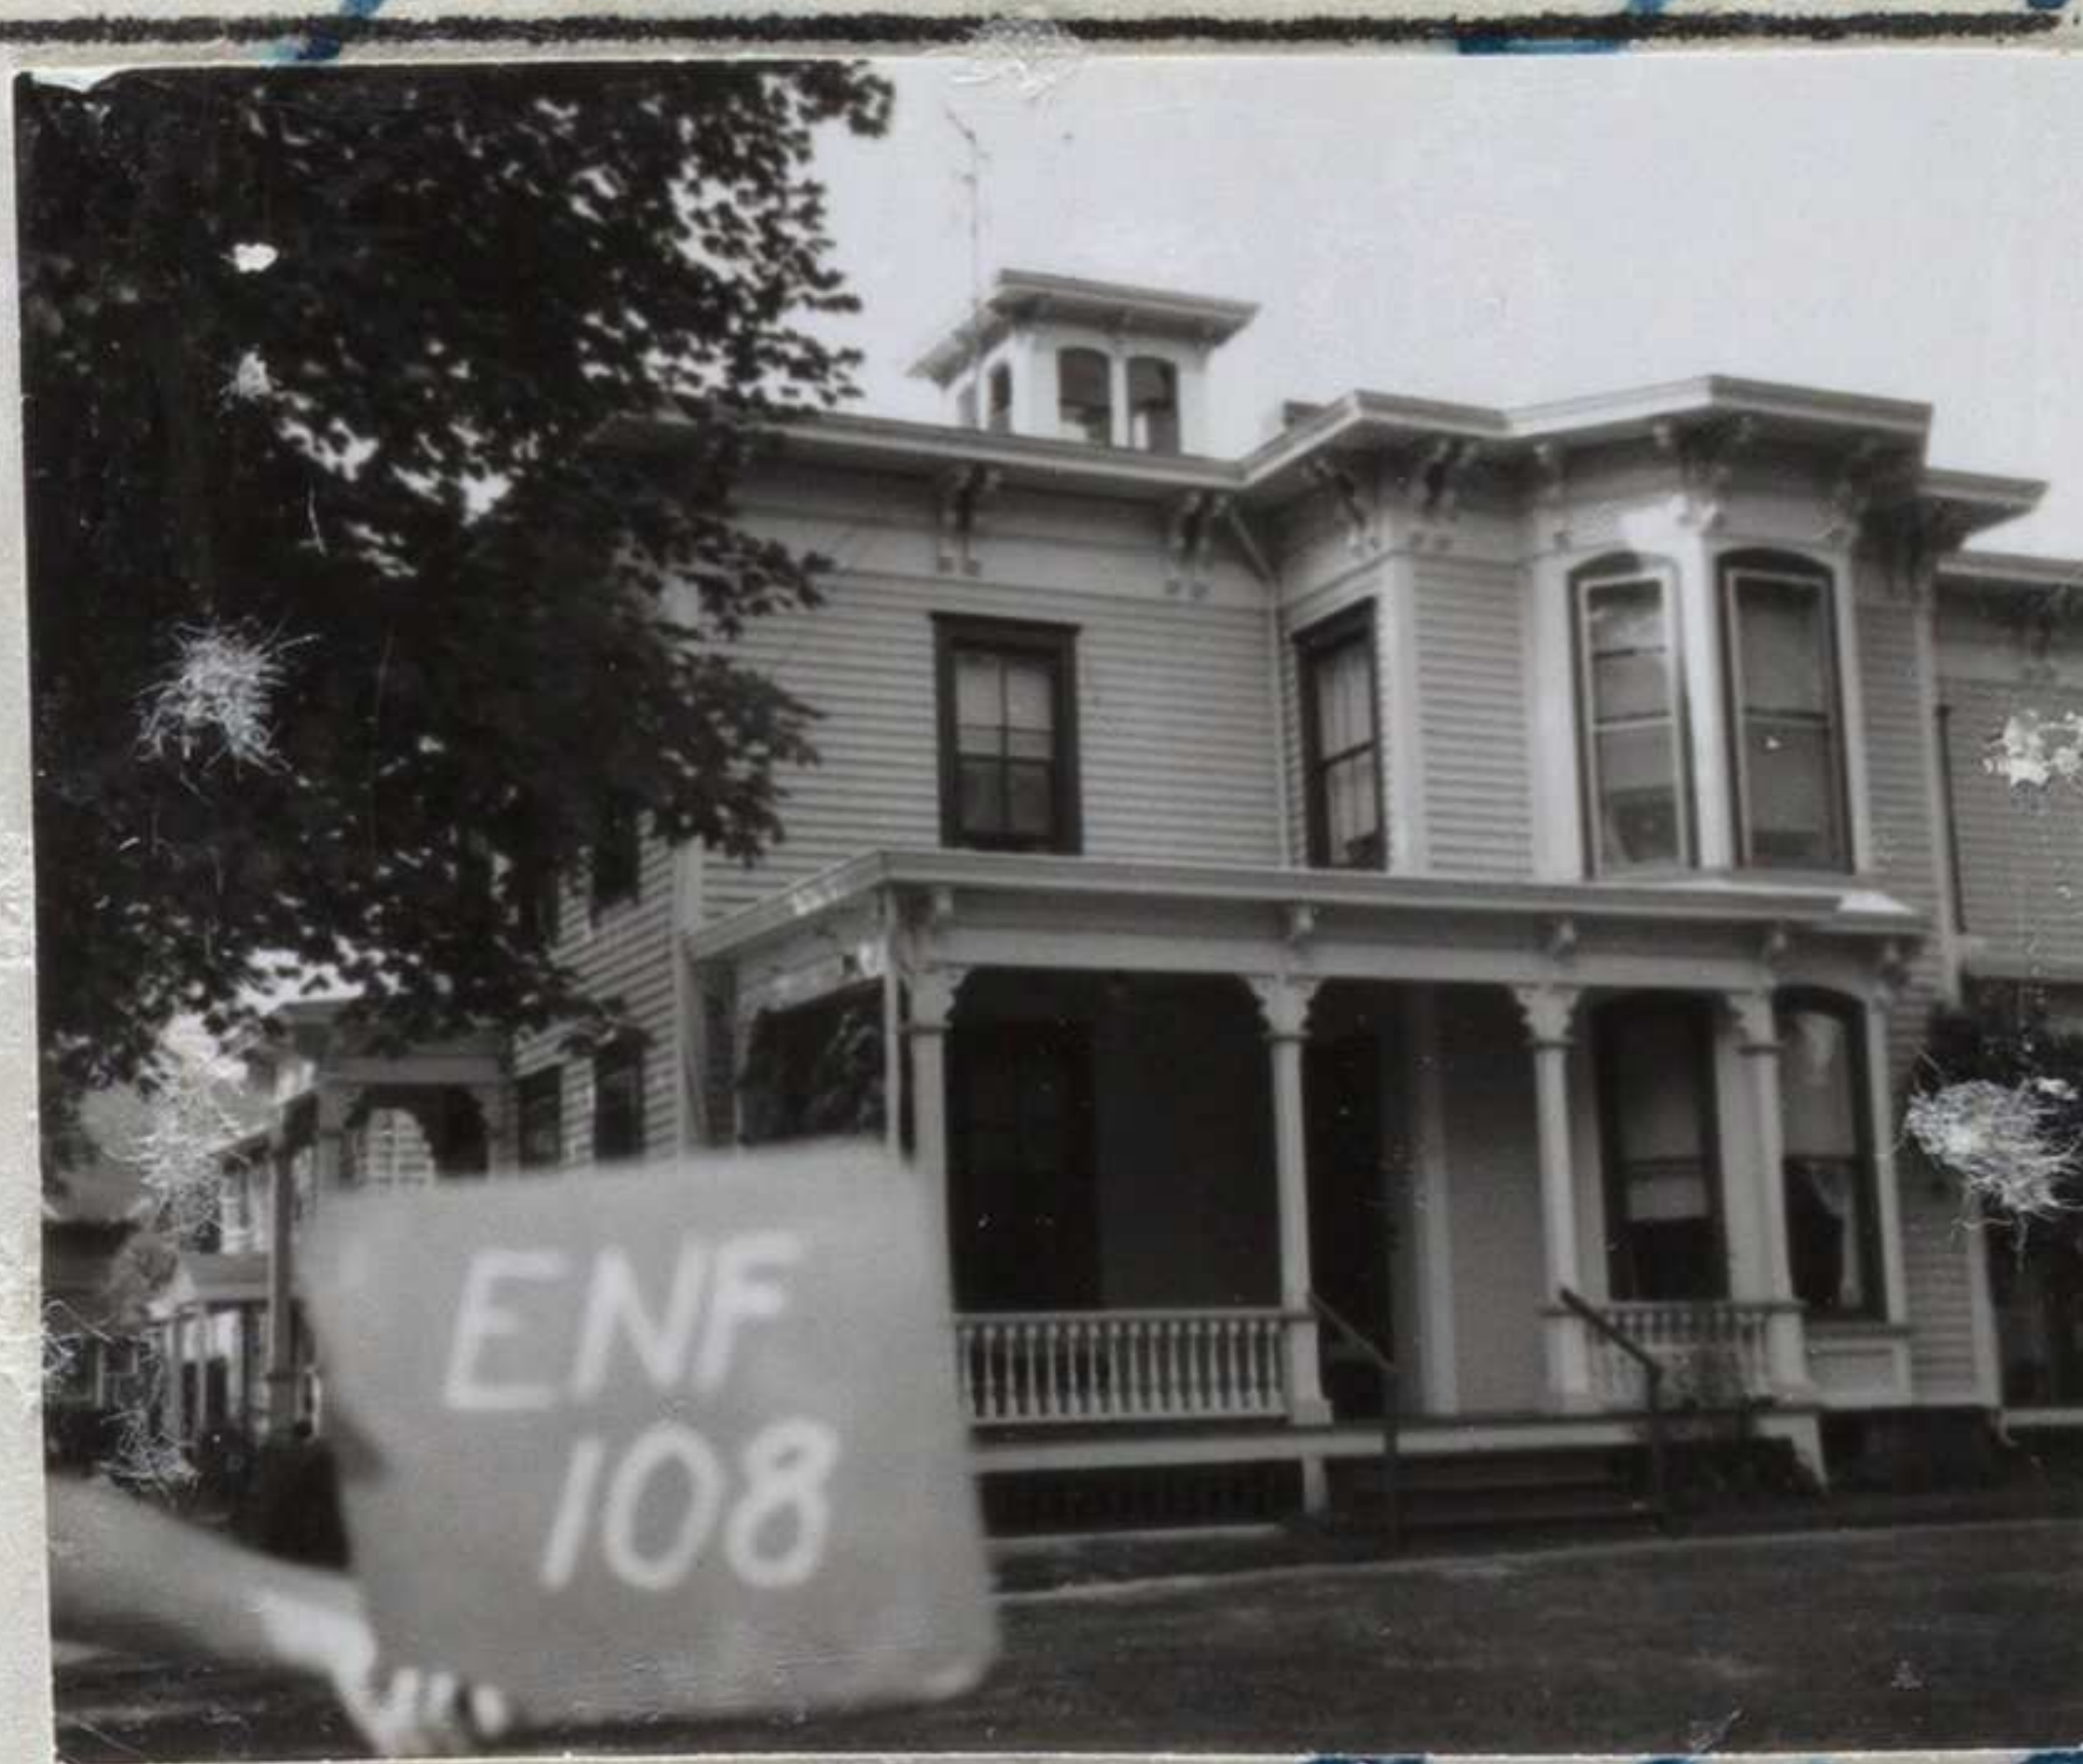
<p>7. PHOTOGRAPH <i>Enf 108</i></p>

<p>5. PHYSICAL CONDITION OF STRUCTURE</p> <p>Endangered <i>No</i> Interior <i>good?</i> Exterior <i>good</i></p>		<p>6. LOCATION MAP (Plan Optional)</p>

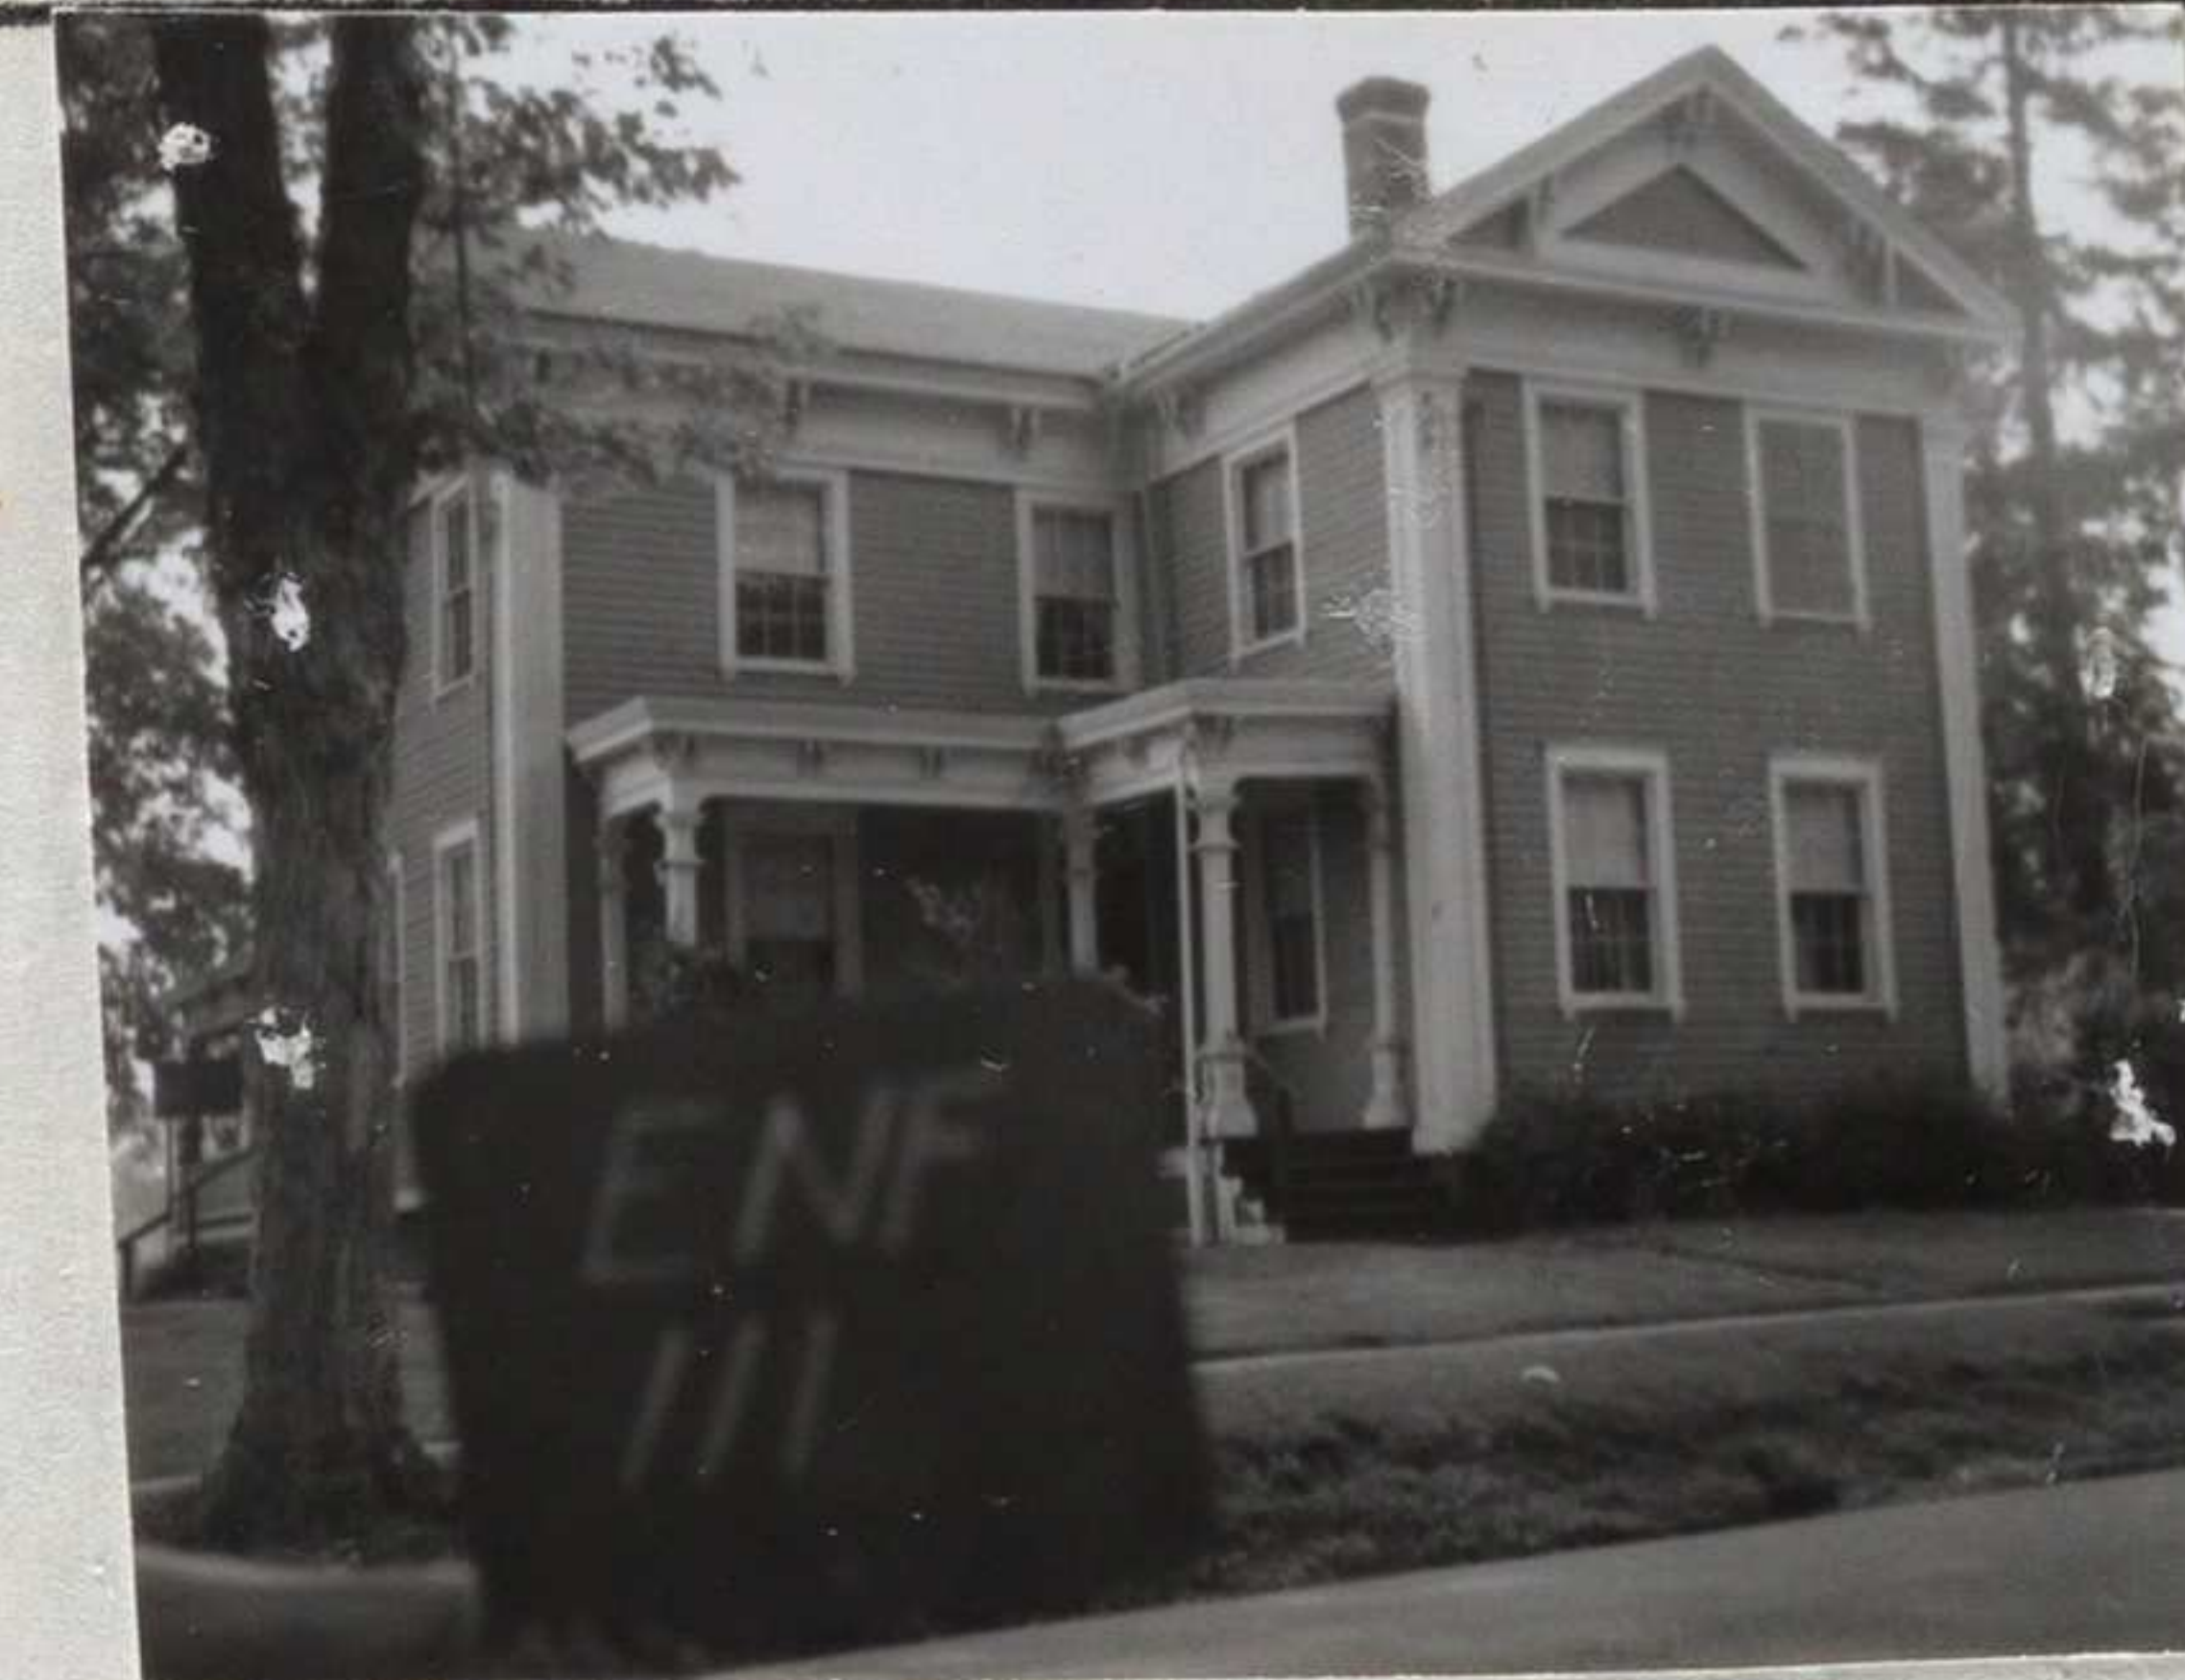
7. PHOTOGRAPH <i>Enf III</i>

4. NOTABLE FEATURES, HISTORICAL SIGNIFICANCE AND DESCRIPTION <i>This "L" shaped house built on a brick foundation and topped with a shallow pitched roof and pediment, the later inscribed with a triangular gable, all plain boarded. The same plain boarding occurs behind the porch which helps to fill the "L". The pilasters supporting the double-bracketed entablature are paneled with dog-tooth tops. The bases to the porch pillars bear star shaped indentations. The windows are 5x6 6x6 and linteled.</i>	OPEN TO PUBLIC <i>NO</i>
	5. PHYSICAL CONDITION OF STRUCTURE Endangered <i>NO</i> Interior <i>Good</i> Exterior <i>Good</i>

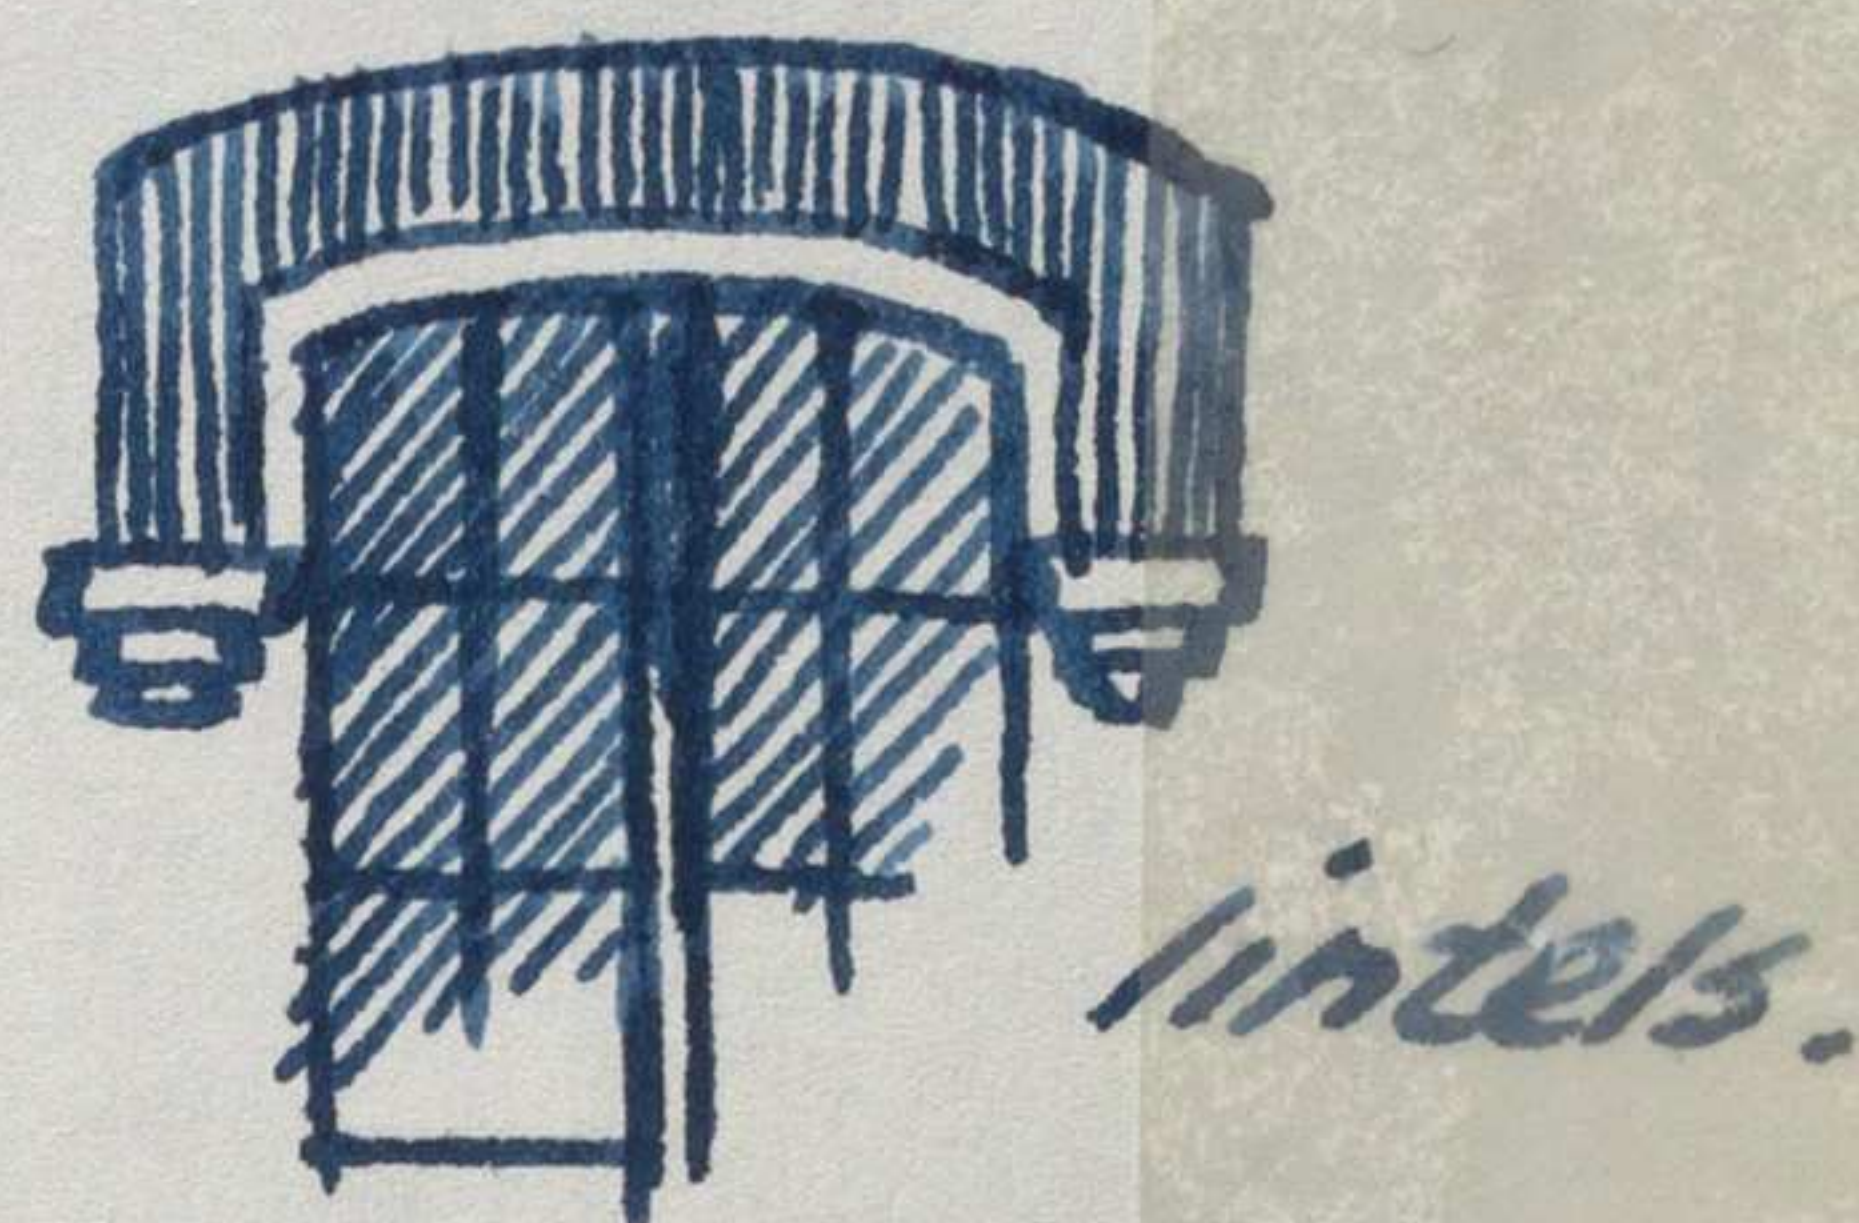
lintels.

This brick building with foundation of brownstone, has a facade of five bays. The segmental topped windows are divided into two segments each with 46 panes, the windows being considerably longer on the second floor than the first. The lintels are ~~made~~ of brownstone, as is the plaque over the door ~~is~~ taking the place of the regular window form. The doorway has the same segmental top. The sides are divided into 2 bays with the same window treatment. Between these there is an end chimney to each side with some inventive brick treatment.

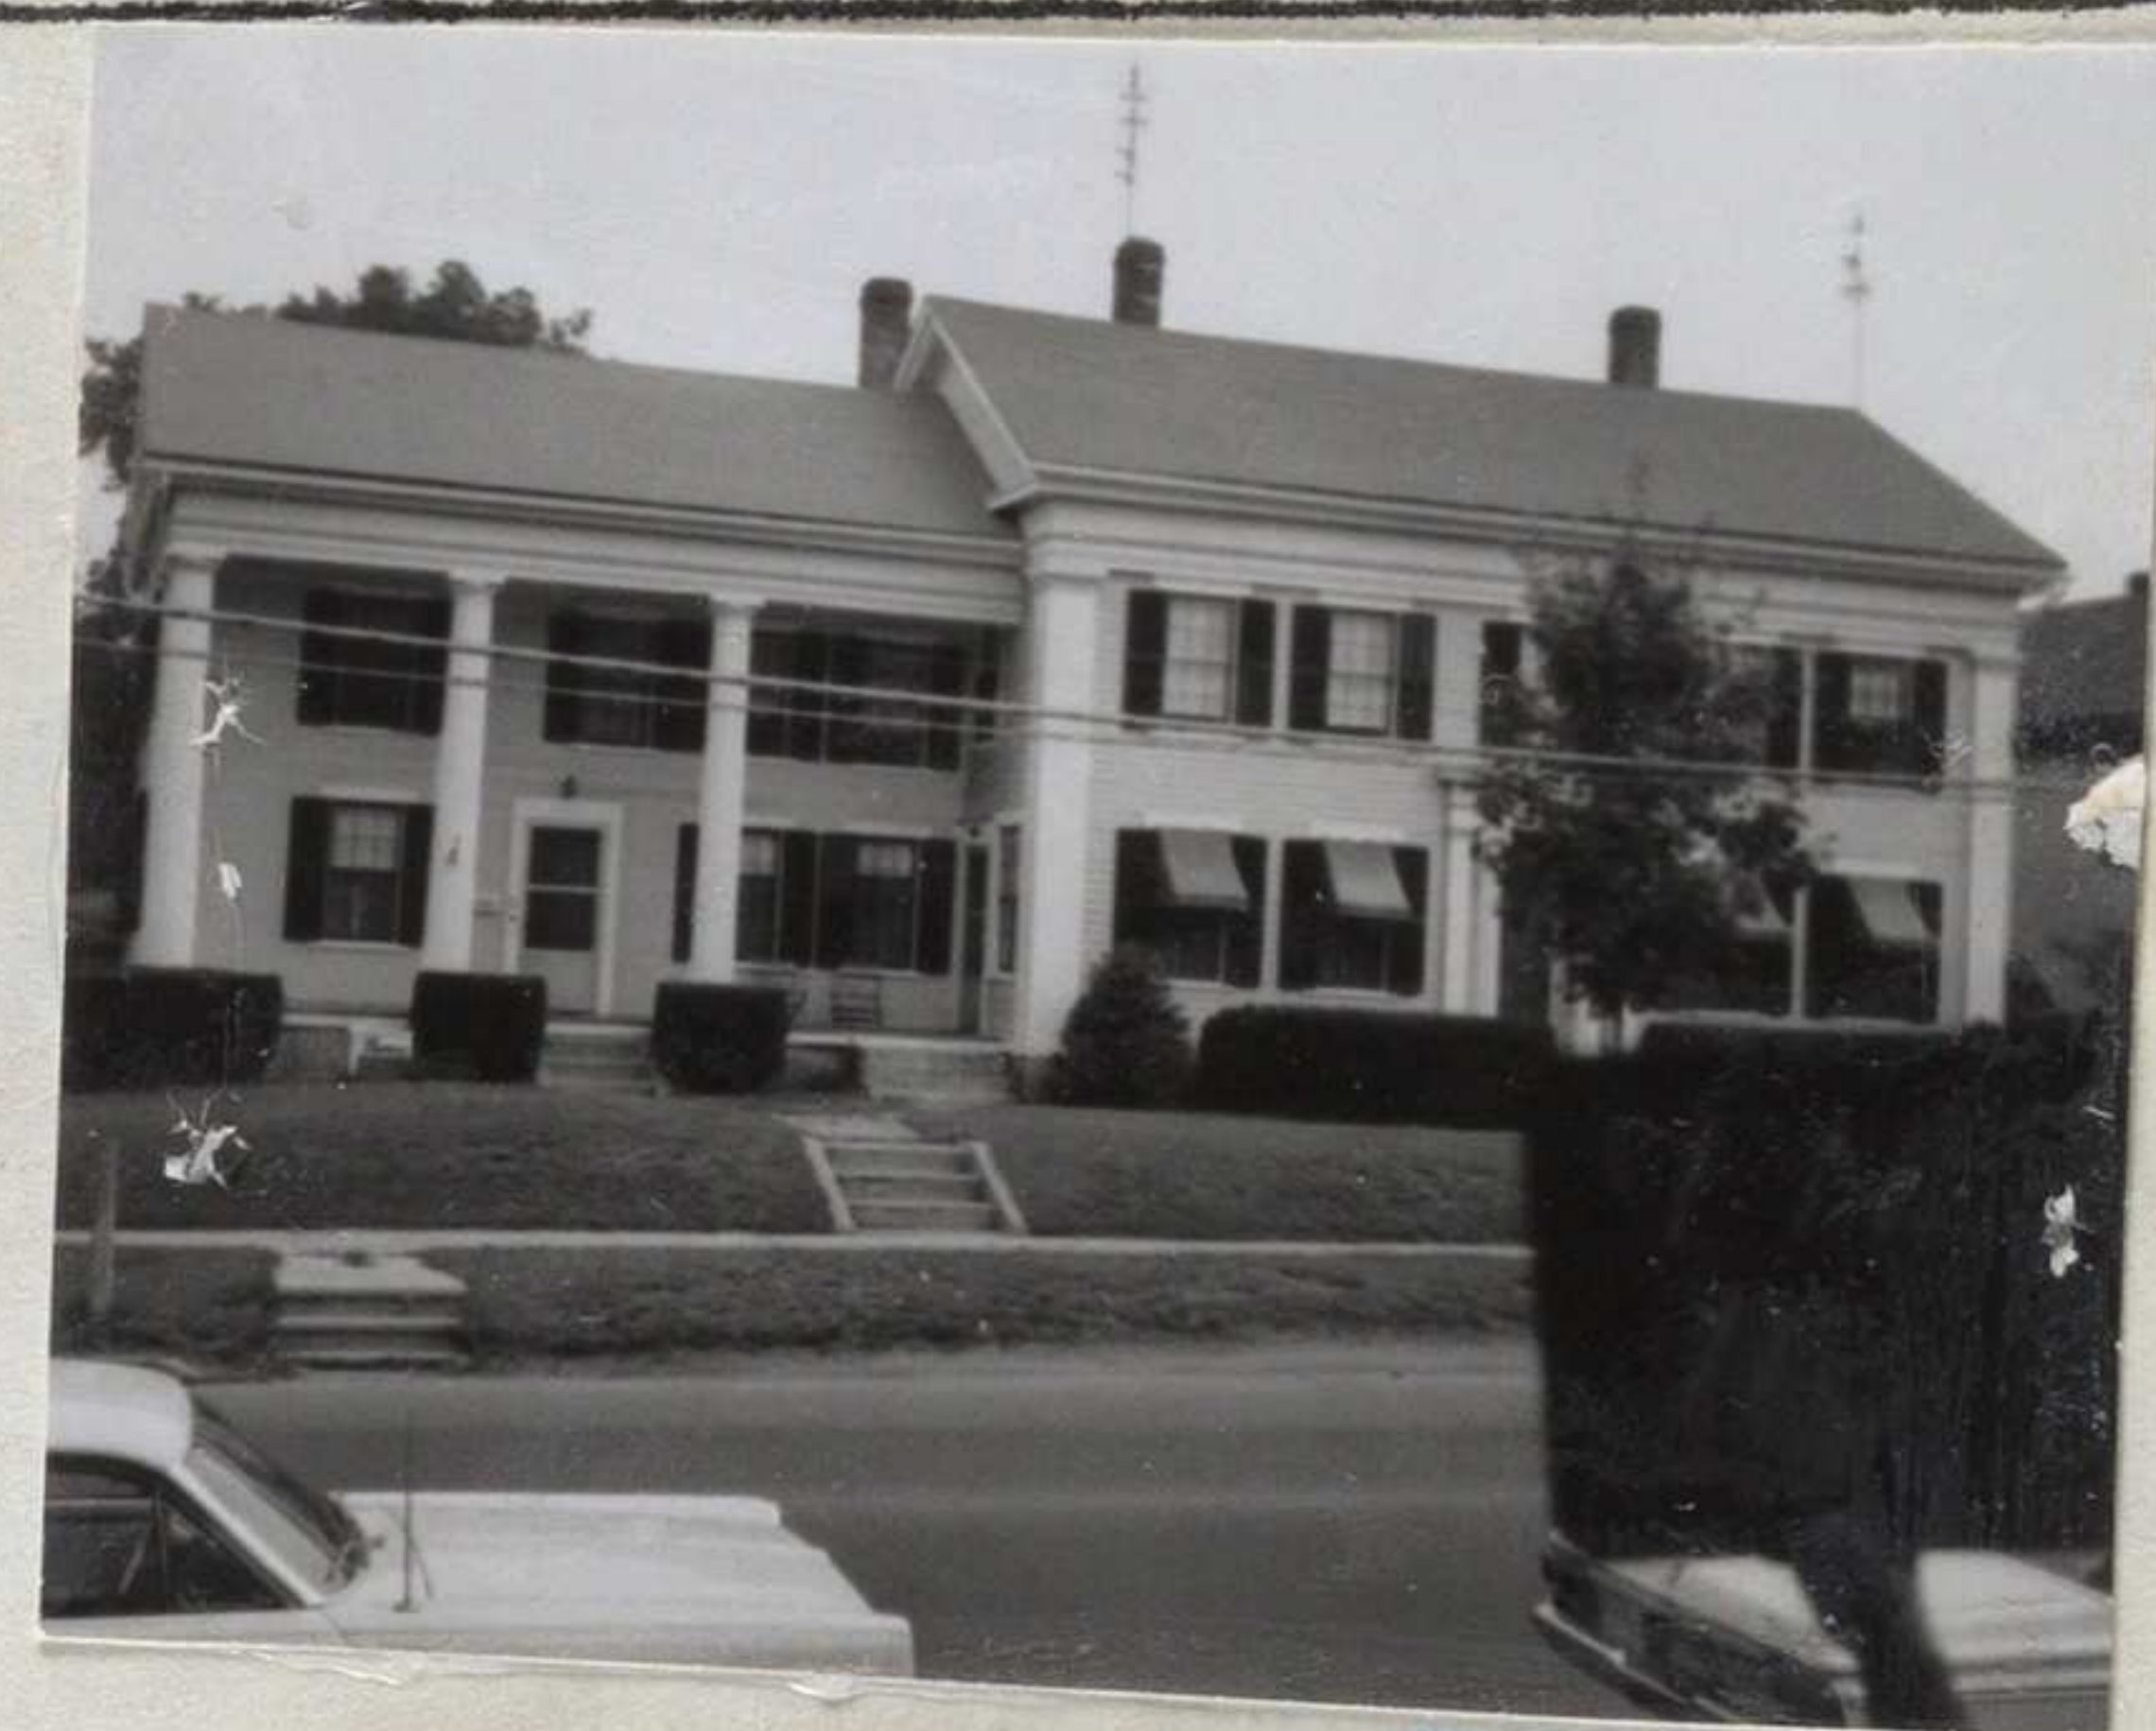
7. PHOTOGRAPH <i>Enf 116</i>

4. NOTABLE FEATURES, HISTORICAL SIGNIFICANCE AND DESCRIPTION <i>This magnificent house is in absolutely dazzling condition. Its owner Mr. Herbert Allen was born there in 1898. Painted yellow with white and yellow trim, with green shutters, it is superb. The main section is of five bays placed upon an amazing granite foundation. The windows are 6/6 panes with shutters. The shallow pitched roof has two new chimneys which have been moved back from the ridgepole. They occur in elevation between the 1st and 2nd, and 4th and 5th bays. The corners are ornamented with doric pilasters supporting an entablature with a three step architrave. The finely pediment mold-</i>	OPEN TO PUBLIC <i>No</i>

5. PHYSICAL CONDITION OF STRUCTURE Endangered <i>No</i> Interior <i>Exc.</i> Exterior <i>Exc.</i>
